USS ARIZONA MEMORIAL and PEARL HARBOR NATIONAL HISTORIC LANDMARK

SUBMERGED CULTURAL RESOURCES STUDY

by Daniel J. Lenihan, Editor Principal Investigator Submerged Cultural Resources Unit

Southwest Cultural Resources Center Professional Papers No. 23

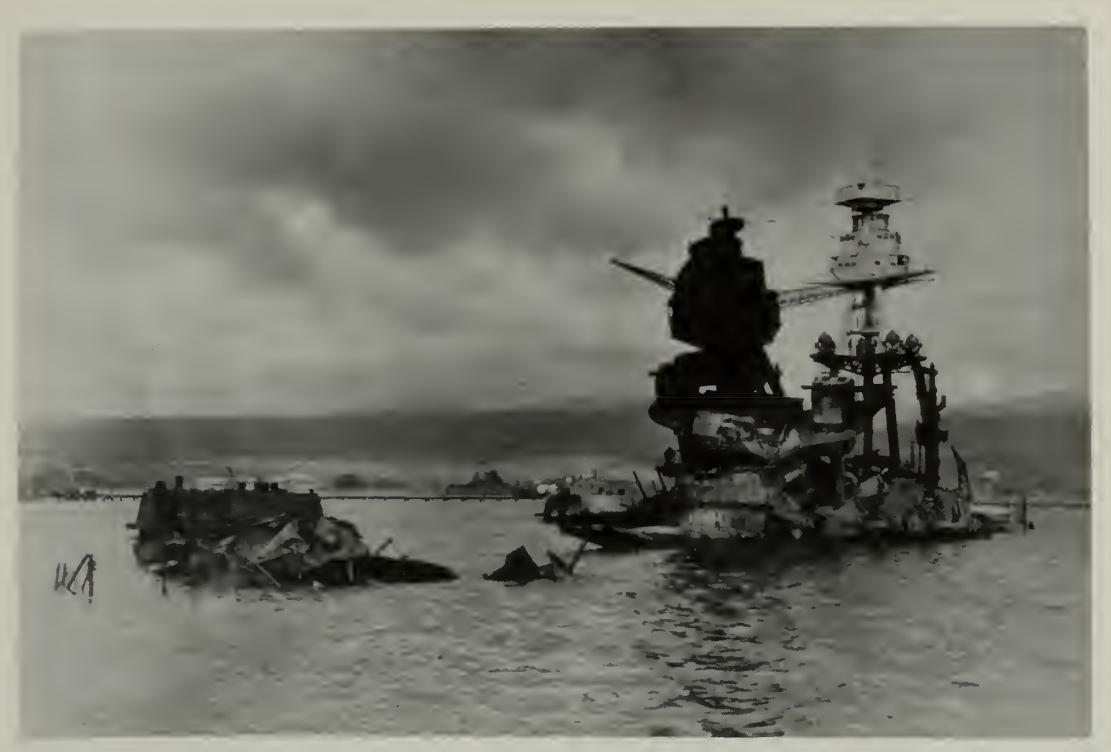
Figure 2.22. Aftermath: December 1941, the USS ARIZONA from port bow looking aft. (NPS: USAR collection)

The ARIZONA received the most serious battle damage of the ships attacked on December 1941. The resultant explosion of ammunition and fuel demolished the forward section of the vessel, which collapsed inside the hull, and killed most of the ship's complement. Six days after the attack, the senior surviving officer from the ARIZONA forwarded the ship's action report to CINCPAC Admiral Kimmel and noted: "The USS ARIZONA is a total loss except the following is believed salvageable: fifty-caliber machine guns in maintop, searchlights on after searchlight platform, the low catapult on quarterdeck and the guns of numbers 3 and 4 turrets" (Memorandum, Commanding Officer, USS ARIZONA to CINCPAC, Pearl Harbor, T.H., December 13, 1941. Copy on file at the USS Arizona Memorial).

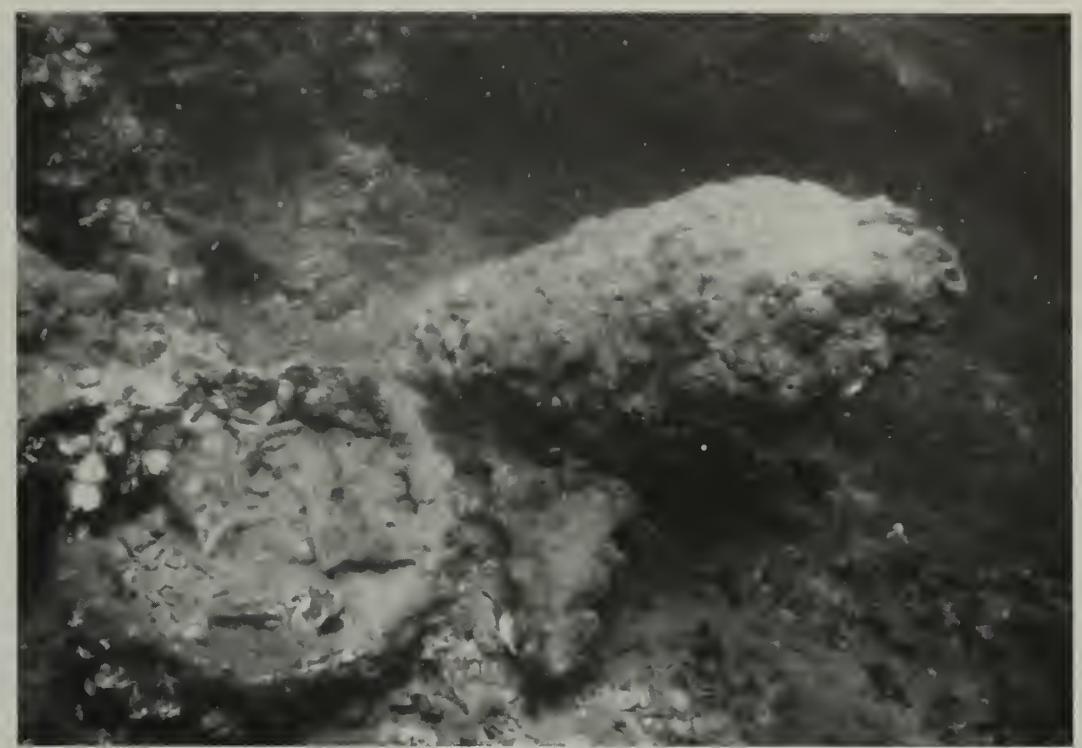
Figure 3.13. Air cylinder protrudes from debris on deck of USS ARIZONA. US Navy EOD divers were called in to rupture the bottle in case it was still under pressure. (NPS photo by Larry Murphy)

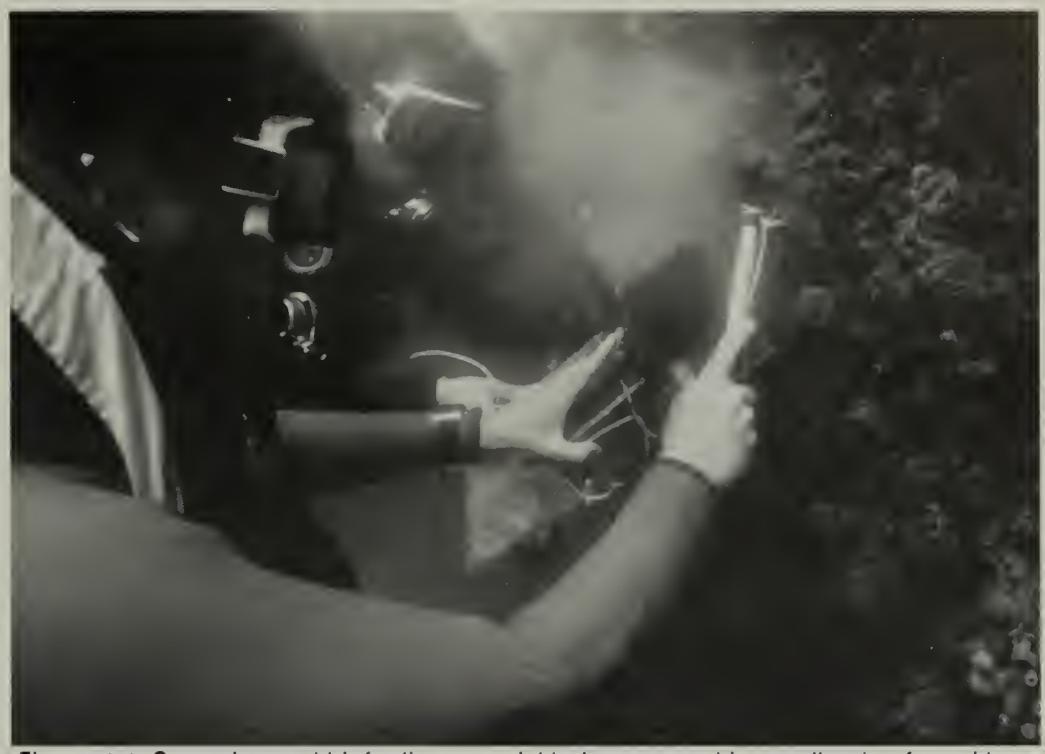
Figure 4.4. Corrosion and biofouling material being scraped into collection funnel by divers. (NPS photo by Larry Murphy)

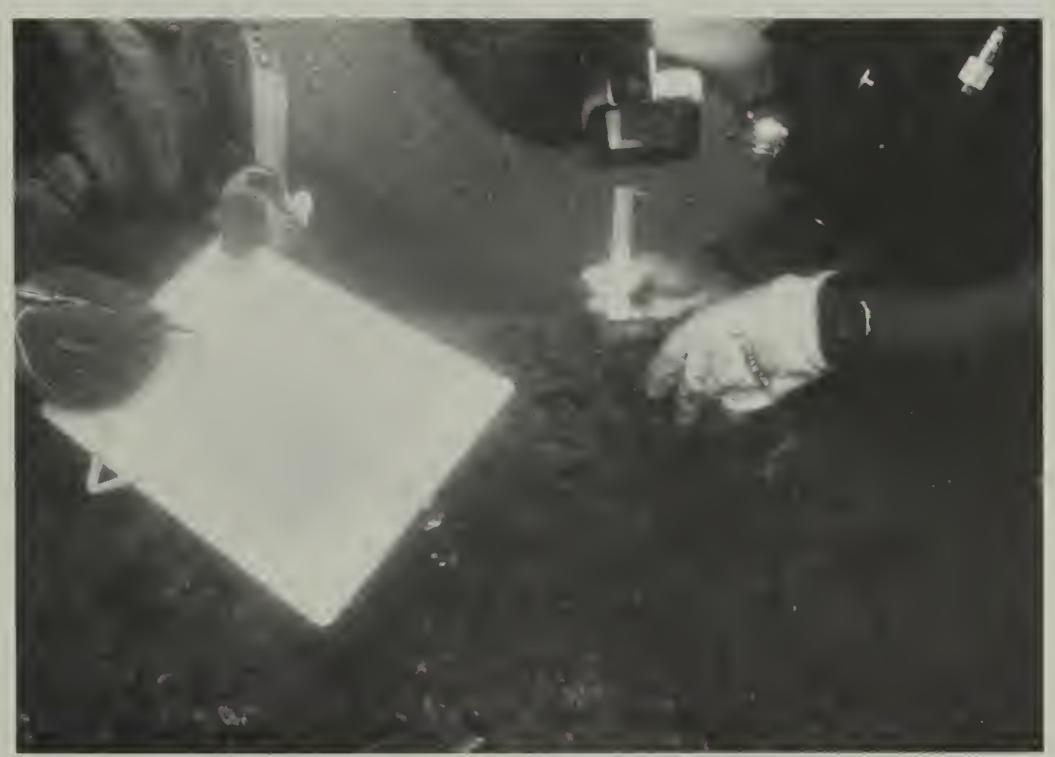
Figure 4.5. Thickness of corrosion and biofouling was measured at selected sampling stations on USS ARIZONA. (NPS photo by Larry Murphy)

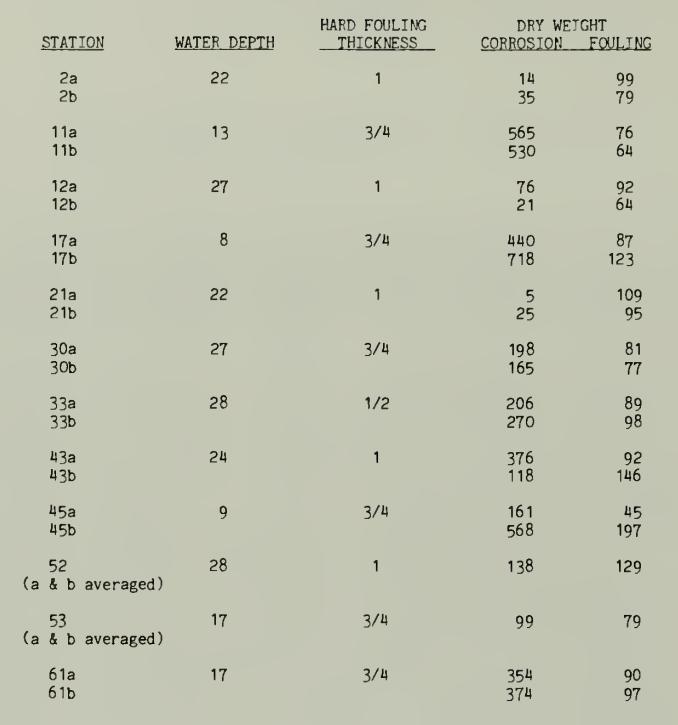
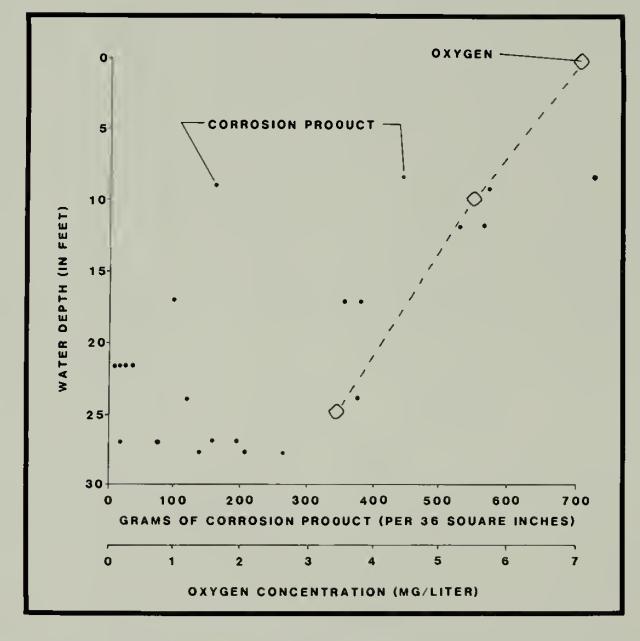
Figure 4.6. Plot of water depth versus grams of corrosion product removed from 36-inch square areas of steel surface at vertical photostations on the USS ARIZONA. For comparative purposes, typical oxygen concentrations that occur at surface and two midwater depths (R.S. Henderson, unpublished Pearl Harbor survey data, 1978-1986) are provided.

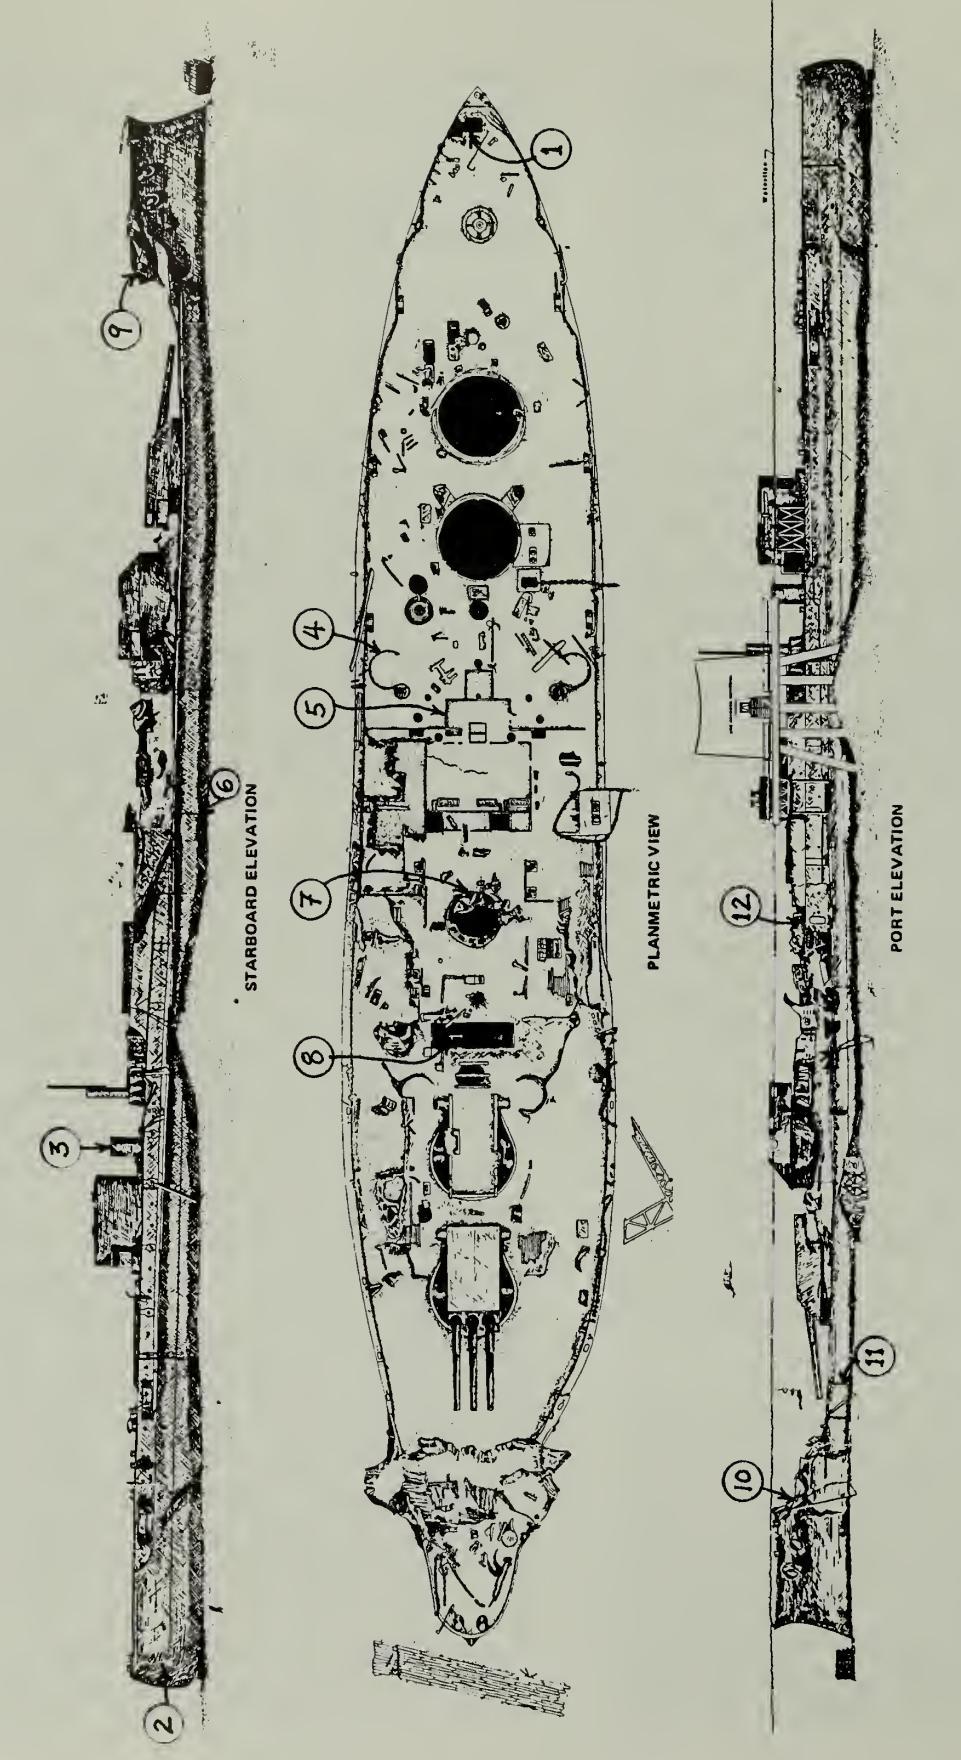
Locations where measurements were made of thickness of corrosion products and underlying shiny steel on edge sections of hull and superstructure fabric on the USS ARIZONA. Figure 4.8.

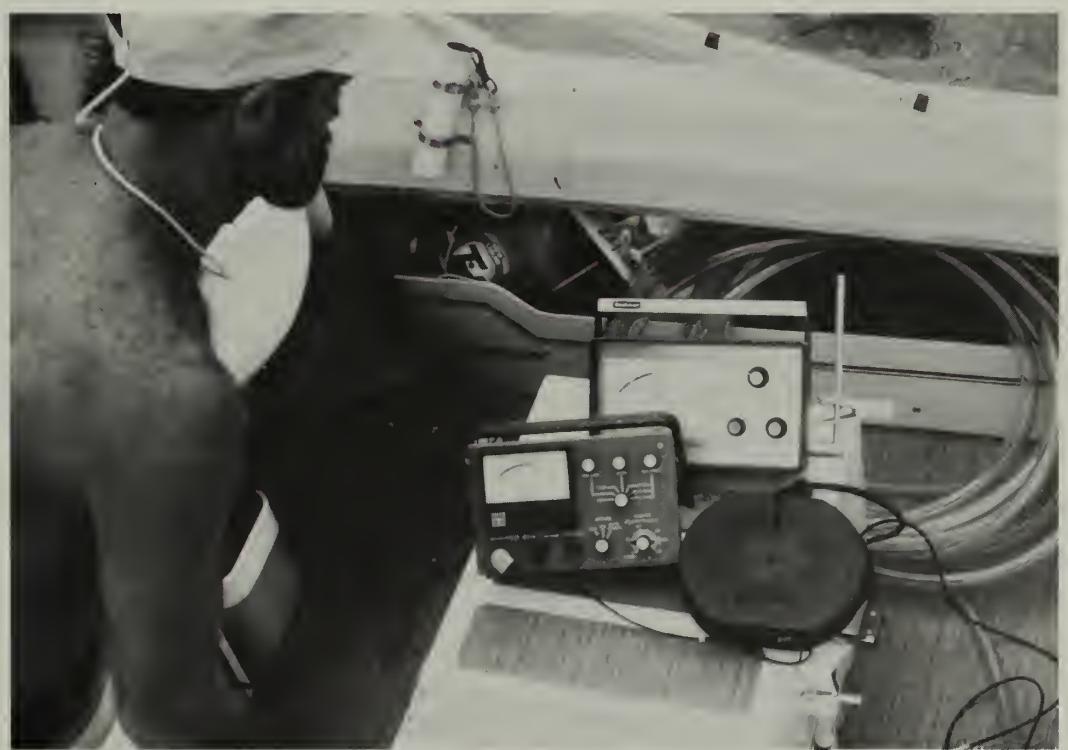
Figure 4.11. On the surface, water drawn from inside the wreck was analyzed for oxygen, temperature and pH levels. (NPS photo by Larry Murphy)
